SI B31 05 17
Front Axle

December 2017
Technical Service

UPDATE! SAFETY RECALL 17V-727: VEHICLE SUSPENSION BOLTS

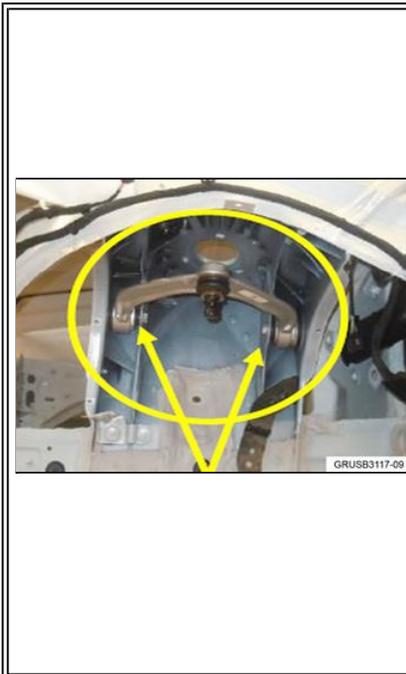
1. Wishbones

C. Visually check on both sides that the nuts and bolts are contacting flat to the contact surface.

D. If not, replace nut with new one and torque bolt (not nut) as per RA to 38 Nm + 90° +/- 15°

E. If yes, mark screw head to see if screw head moves when torquing to 38 Nm. When torquing hold nut turn screw.

- if the screw head did not move the connection is OK
- if the screw head moved the nut needs to be replaced with a new one and the connection needs to be torqued as per RA to 38 Nm + 90° +/- 15°

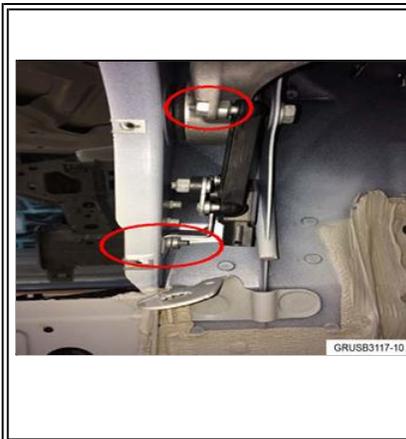
2. Linkage for level sensor on control arm and level sensor bracket on chassis (If equipped)

A. Visually check if all components are contacting without space in between.

- If no, replace nut and torque as per RA to 8 Nm.
- If yes, check with 5 Nm. When checking torque hold screw with wrench to prevent turning.

If the nut does not turn the connection is OK

If the nut turns, the nut needs to be replaced with a new one and the connection needs to be torqued via the screw to 8 Nm
